**NASA CONTRACTOR  
REPORT**

NASA CR-2884

**LOAN COPY: RETURN TO  
AFWL TECHNICAL LIBRARY  
KIRTLAND AFB, N. M.****MODEL PREDICTIONS OF WIND  
AND TURBULENCE PROFILES  
ASSOCIATED WITH AN ENSEMBLE  
OF AIRCRAFT ACCIDENTS**

AERONAUTICAL RESEARCH ASSOCIATES OF PRINCETON, INC.

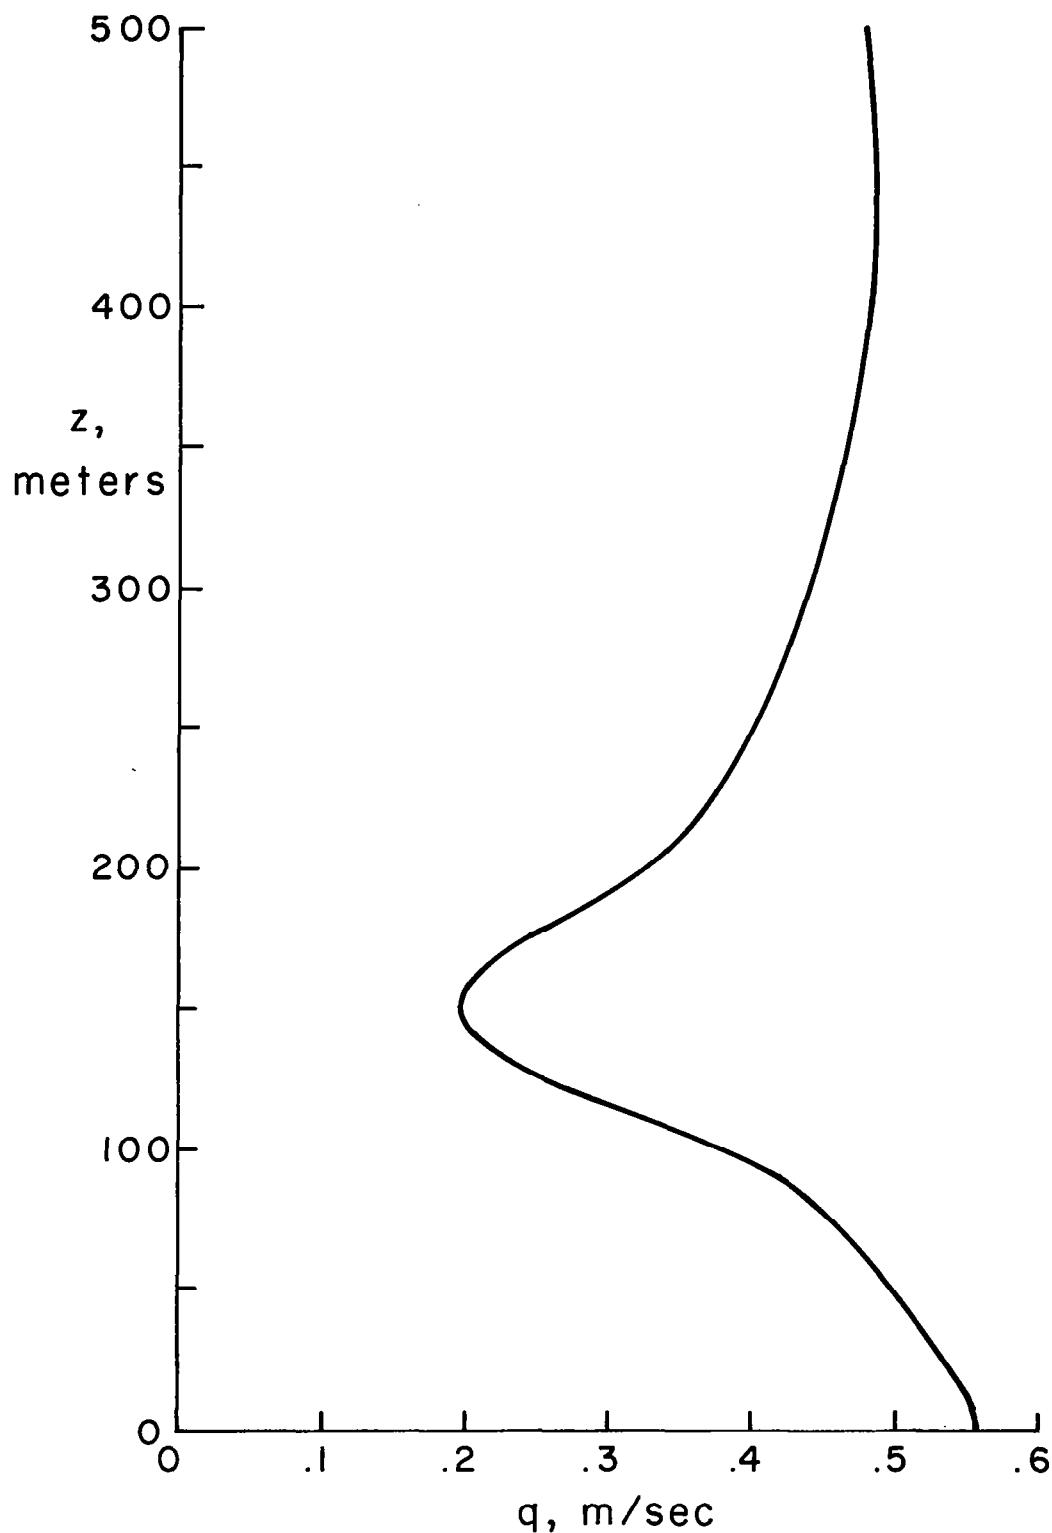
Figure 3.5.9. Altitude profile of variance of the total velocity variance for JFK Airport, December 12, 1972 accident.

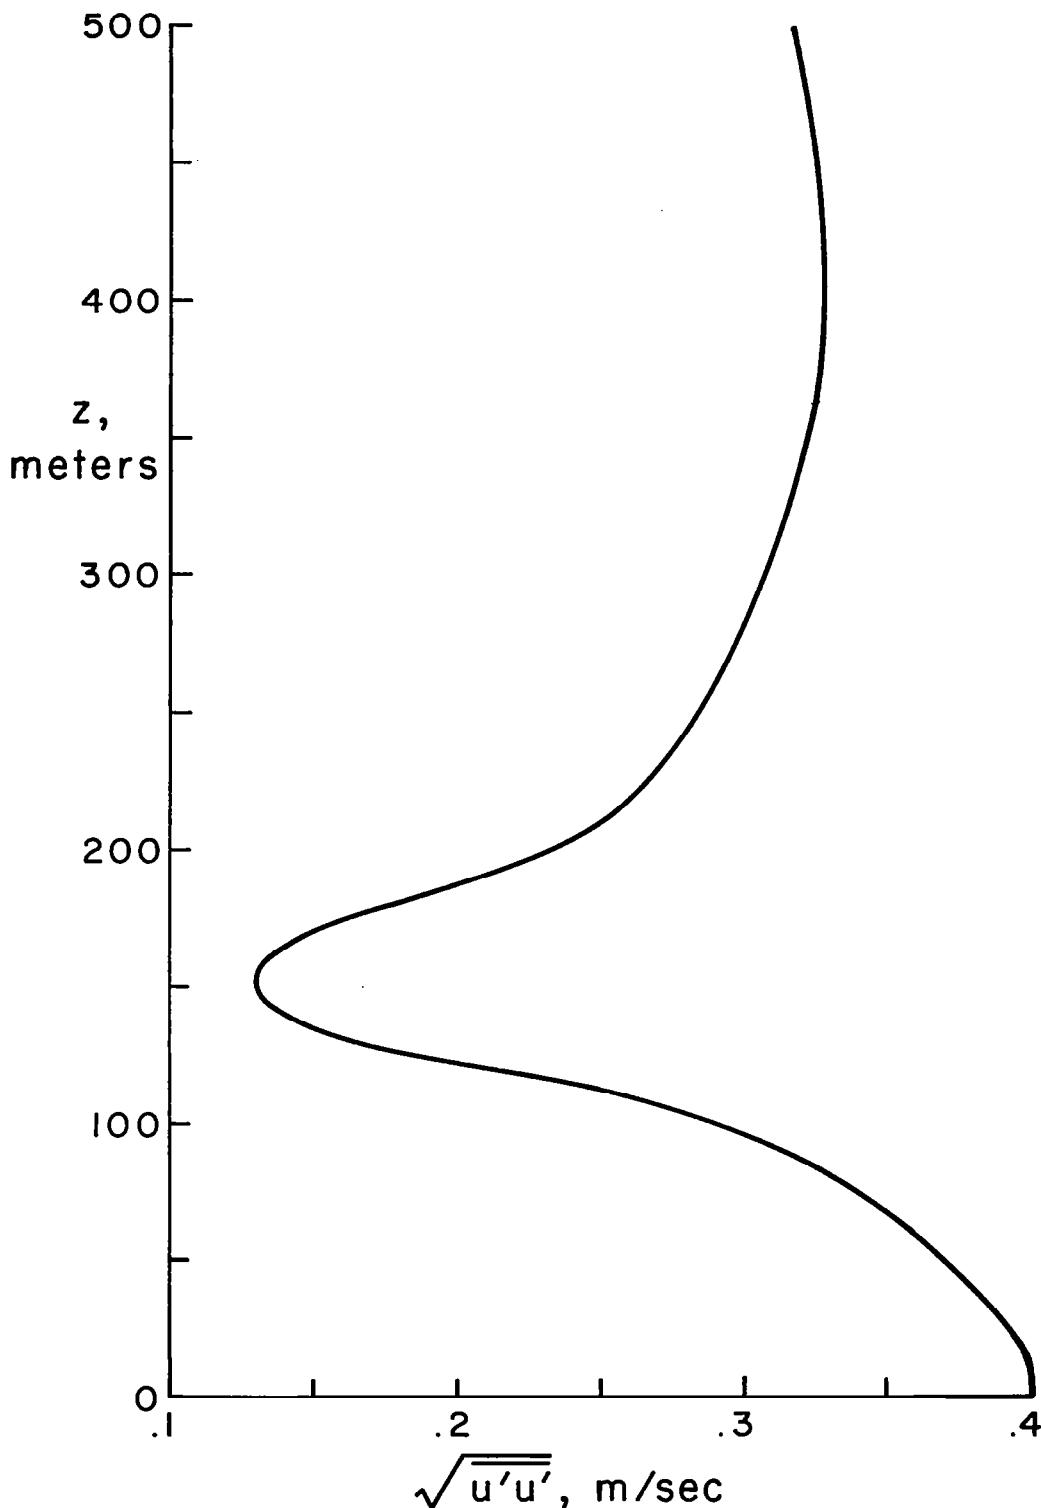
Figure 3.5.10. Altitude profile of variance of the wind parallel to runway for JFK Airport, December 12, 1972 accident.

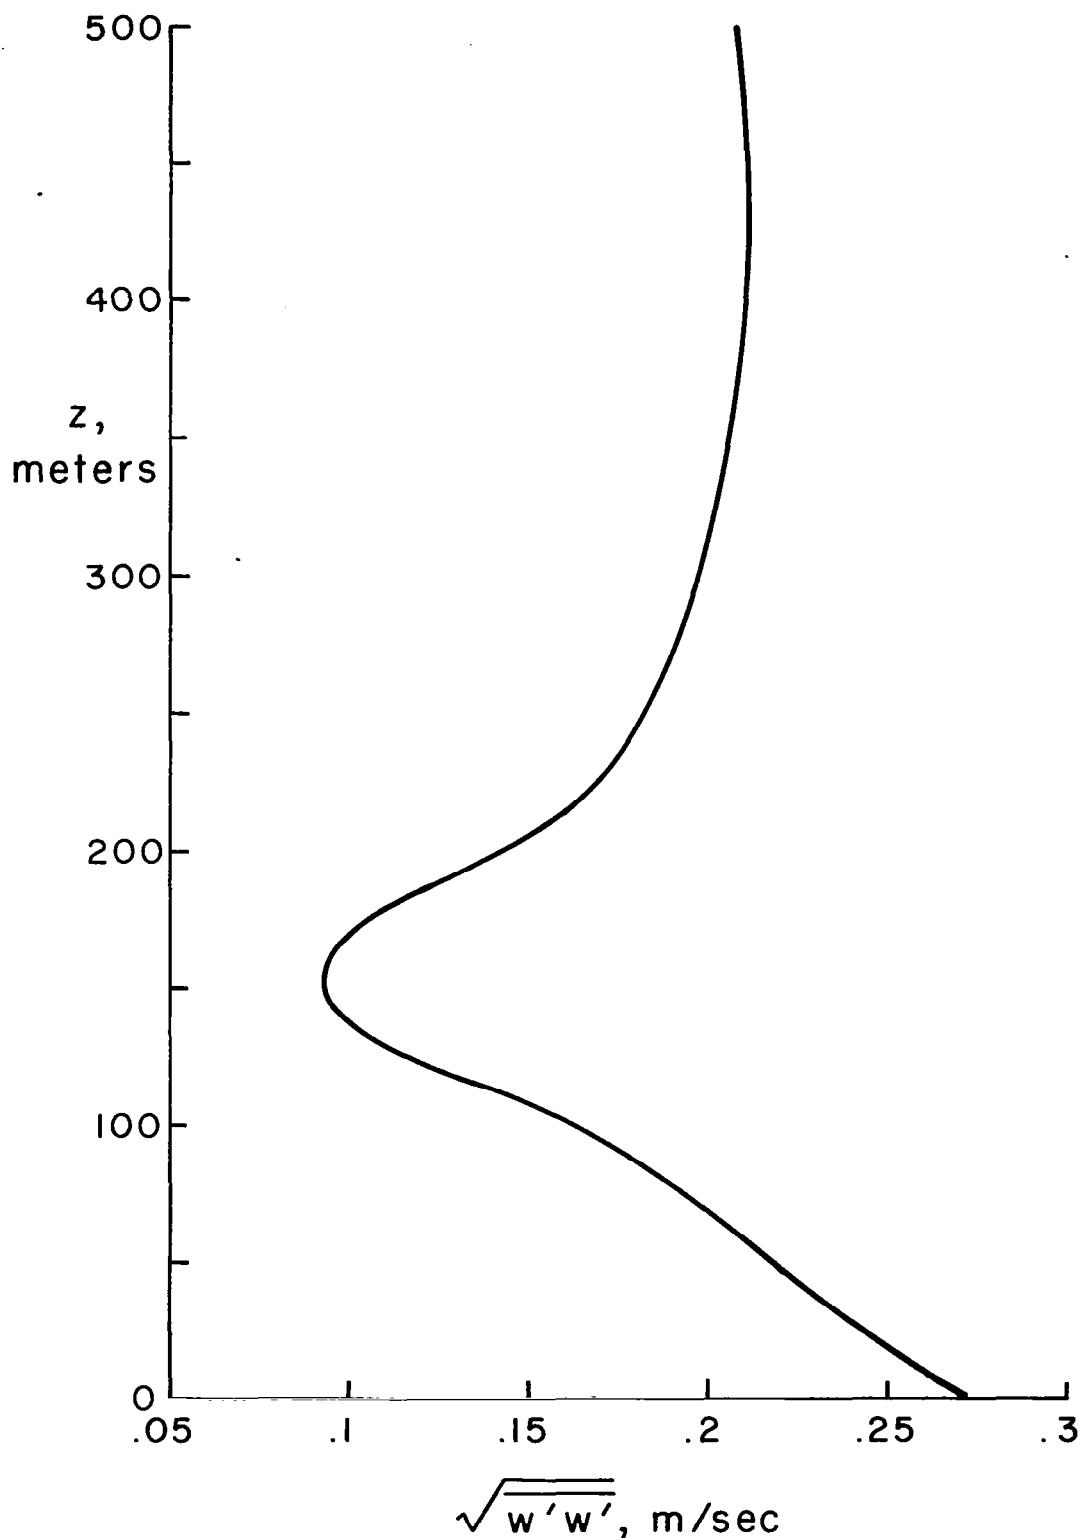
Figure 3.5.12. Altitude profile of variance of the vertical wind for JFK Airport, December 12, 1972 accident.

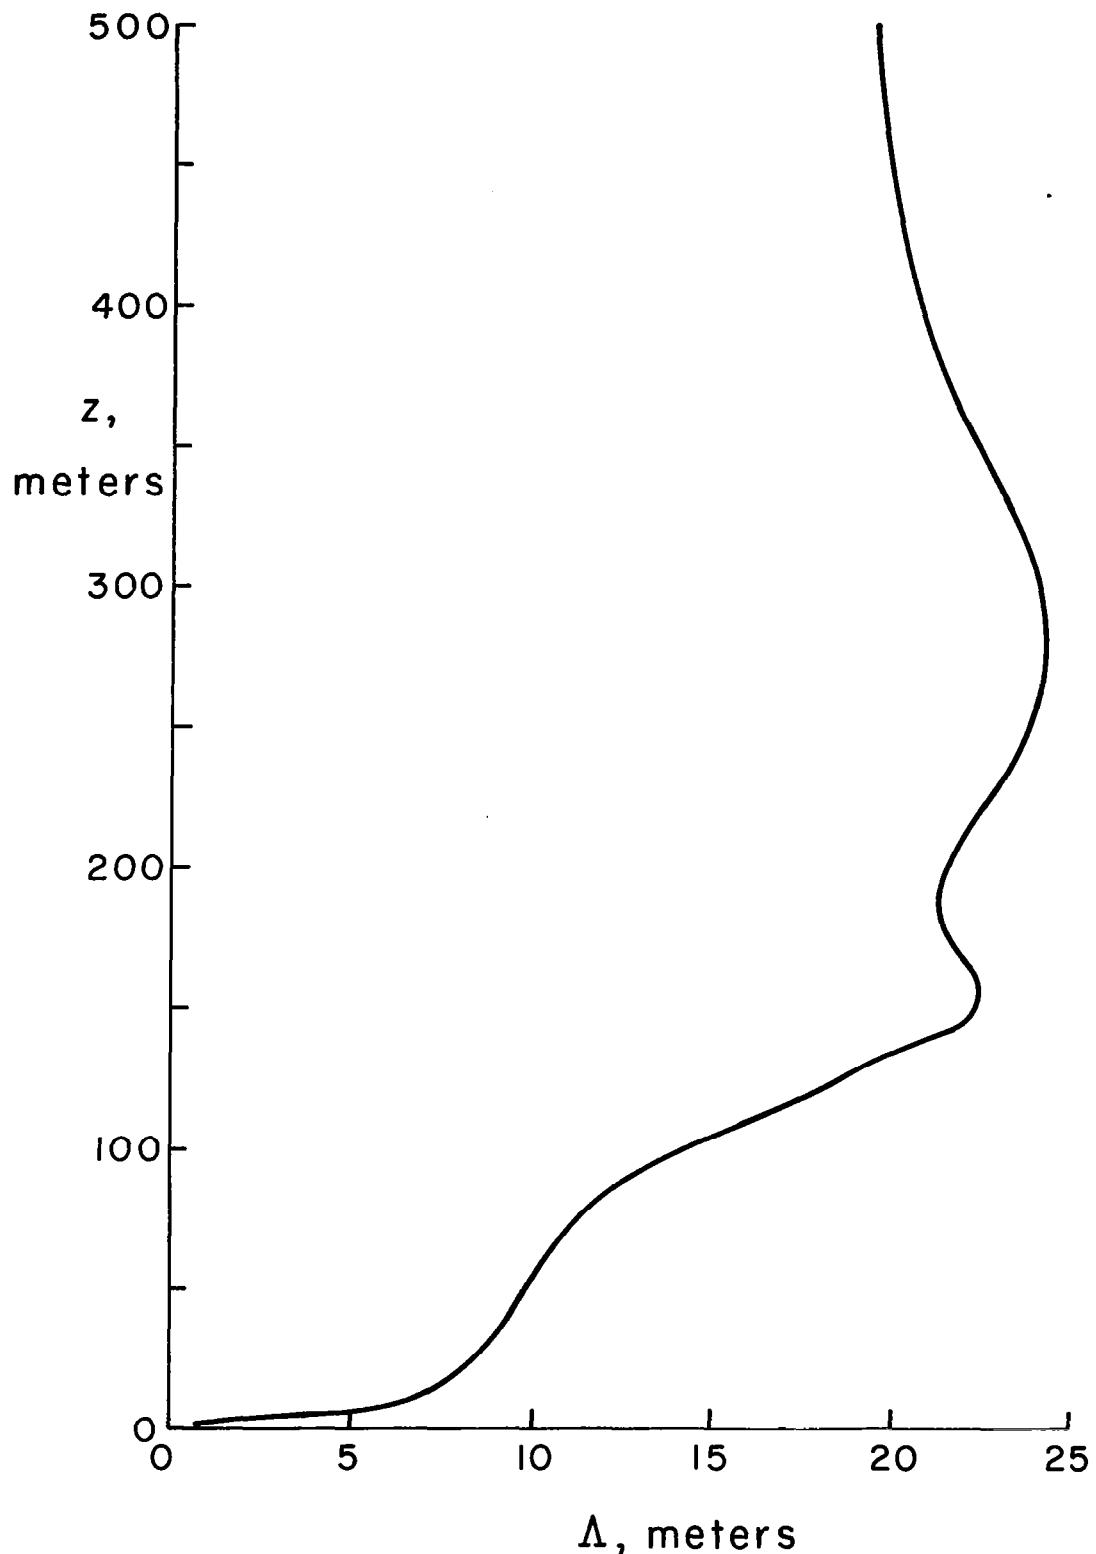
Figure 3.5.13. Altitude profile of scale of turbulence for JFK Airport, December 12, 1972 accident.

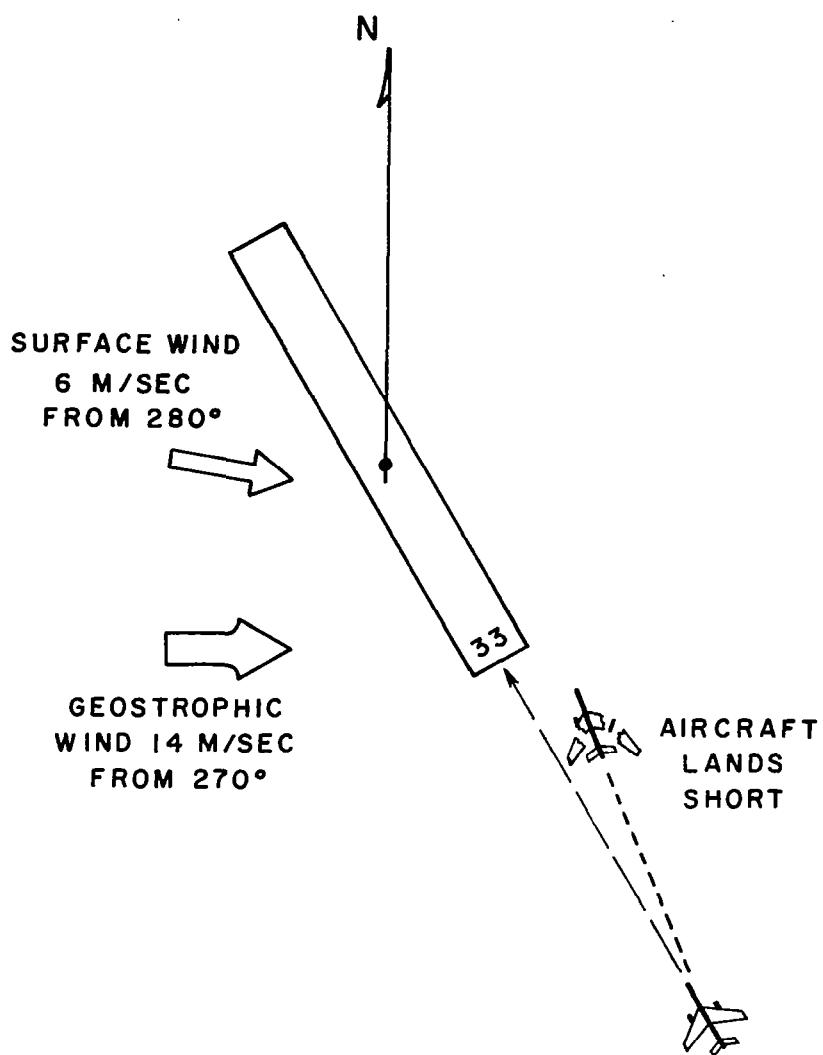
Figure 3.6.1. Aircraft-runway-winds orientation diagram for Johnstown, Pa., January 6, 1974 accident.

At 1905 l.s.t. on January 6, 1974 an Air East Beechcraft 99A crashed while attempting to land on Runway 33 at the Johnstown Airport, Pennsylvania (figure 3.6.1). The aircraft was making an ILS approach in light snow and fog conditions when it struck an approach light tower 90 m from the runway threshold and crashed into an embankment 60 m from the threshold.

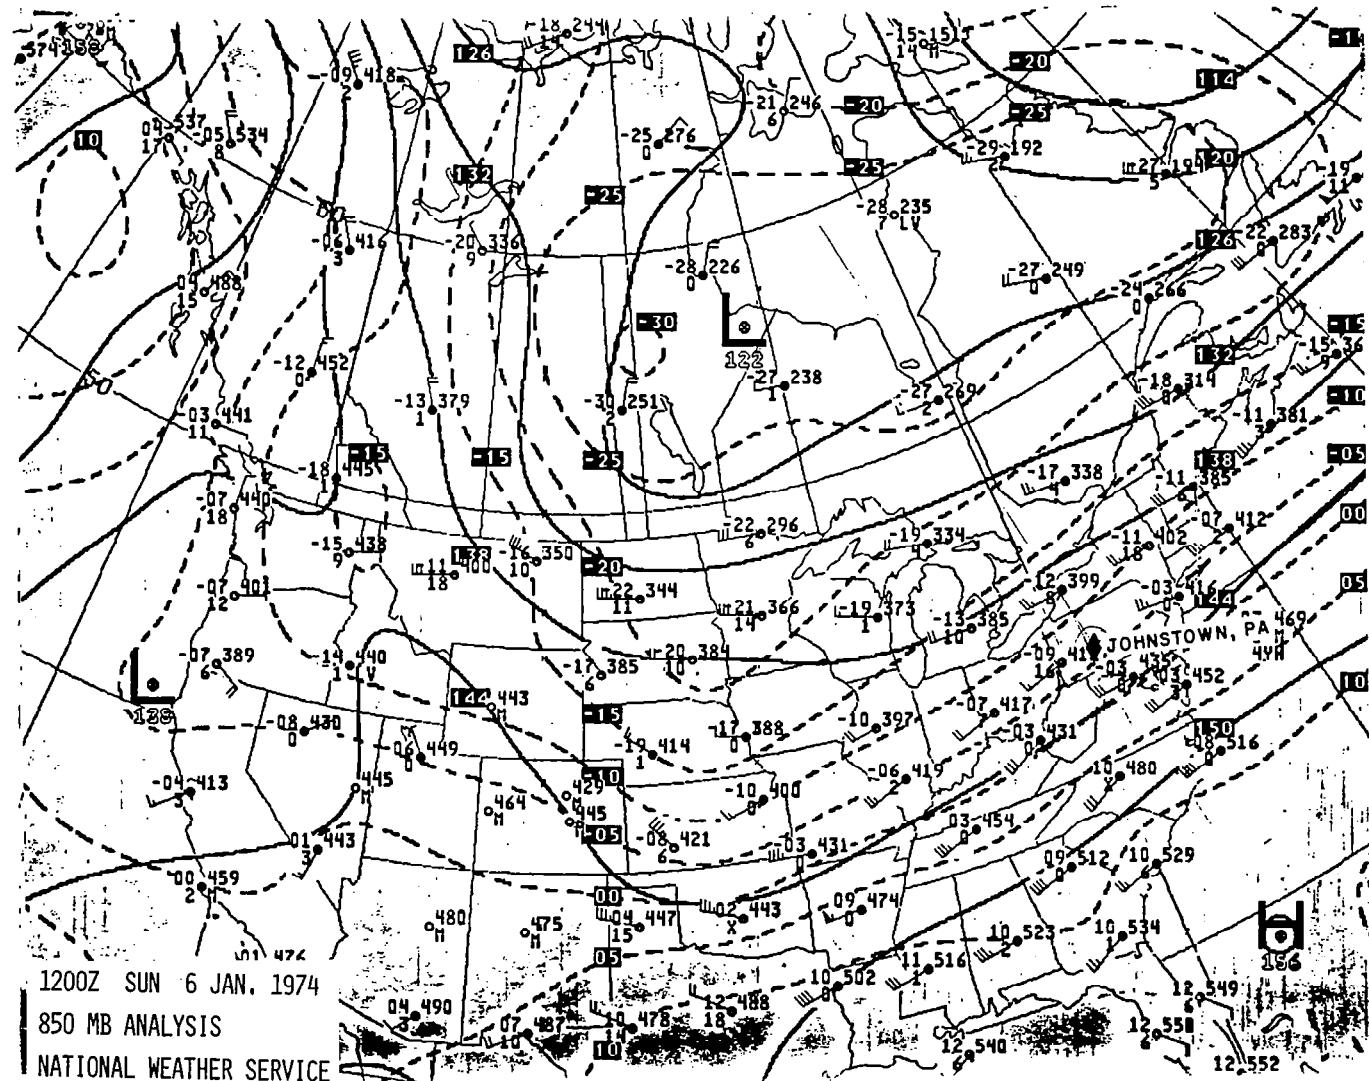
Figure 3.6.2. Early 850 mb chart for Johnstown, Pa., January 6, 1974 accident.

NWS radar at Pittsburgh indicated no precipitation echoes in the Johnstown area at the time of the accident. At this time, the geostrophic wind velocity at the 850 mb altitude was 14 m/sec from 270° and the surface wind was 6 m/sec from 280° (figures 3.6.2 - 3.6.5). Radiosonde data indicated conditionally unstable air below 1300 mean sea level (m.s.l.) (figure 3.6.6). The above conditions would not be expected to produce hazardous wind shear. However, the case was further investigated and profiles characteristic of this weather situation were generated. As expected, the unstable air does not support significant wind shear so the major velocity changes occur above this layer and at ground level (figures 3.6.7 and 3.6.8).

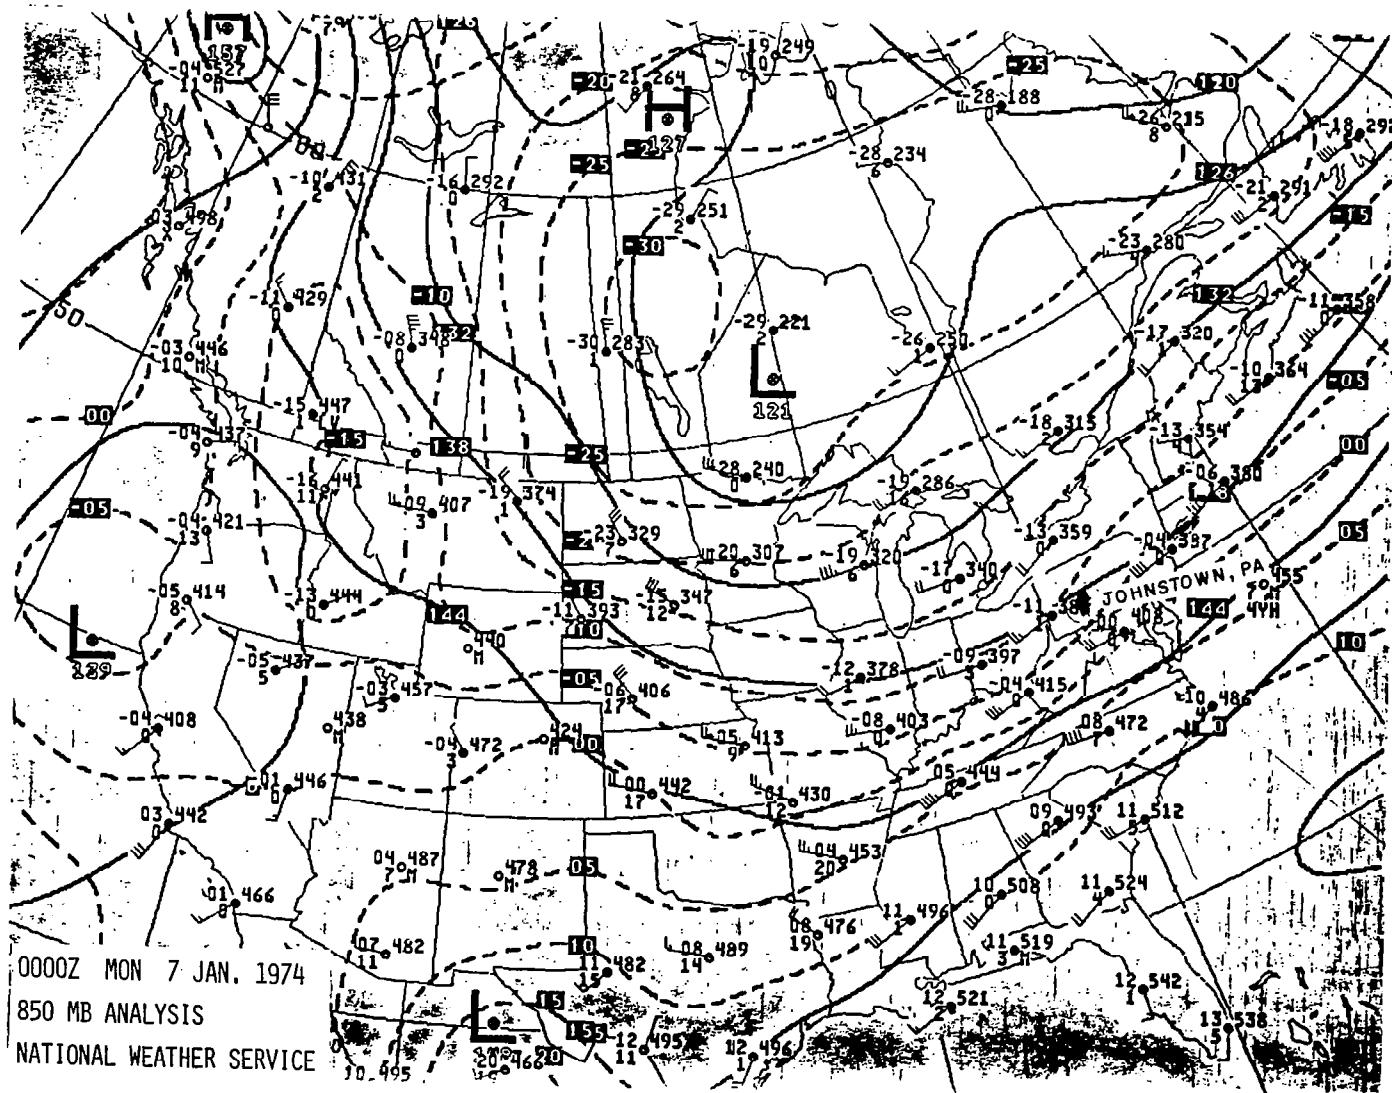
Figure 3.6.3. Late 850 mb chart for Johnstown, Pa., January 6, 1974 accident.

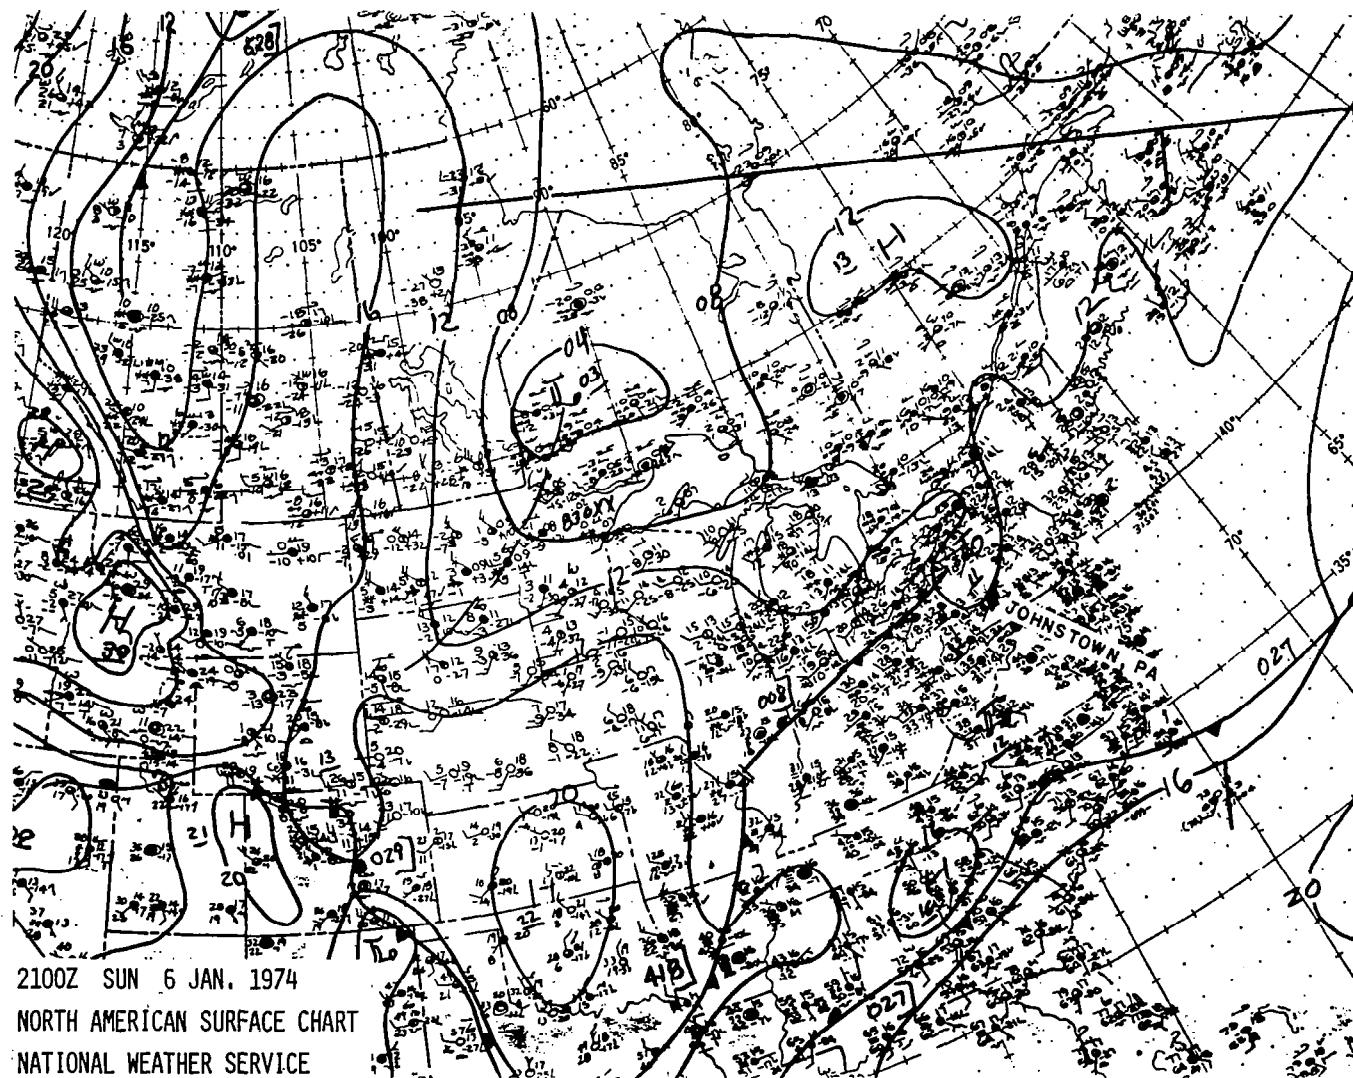
Figure 3.6.4. Early surface weather chart for Johnstown, Pa., January 6, 1974 accident.

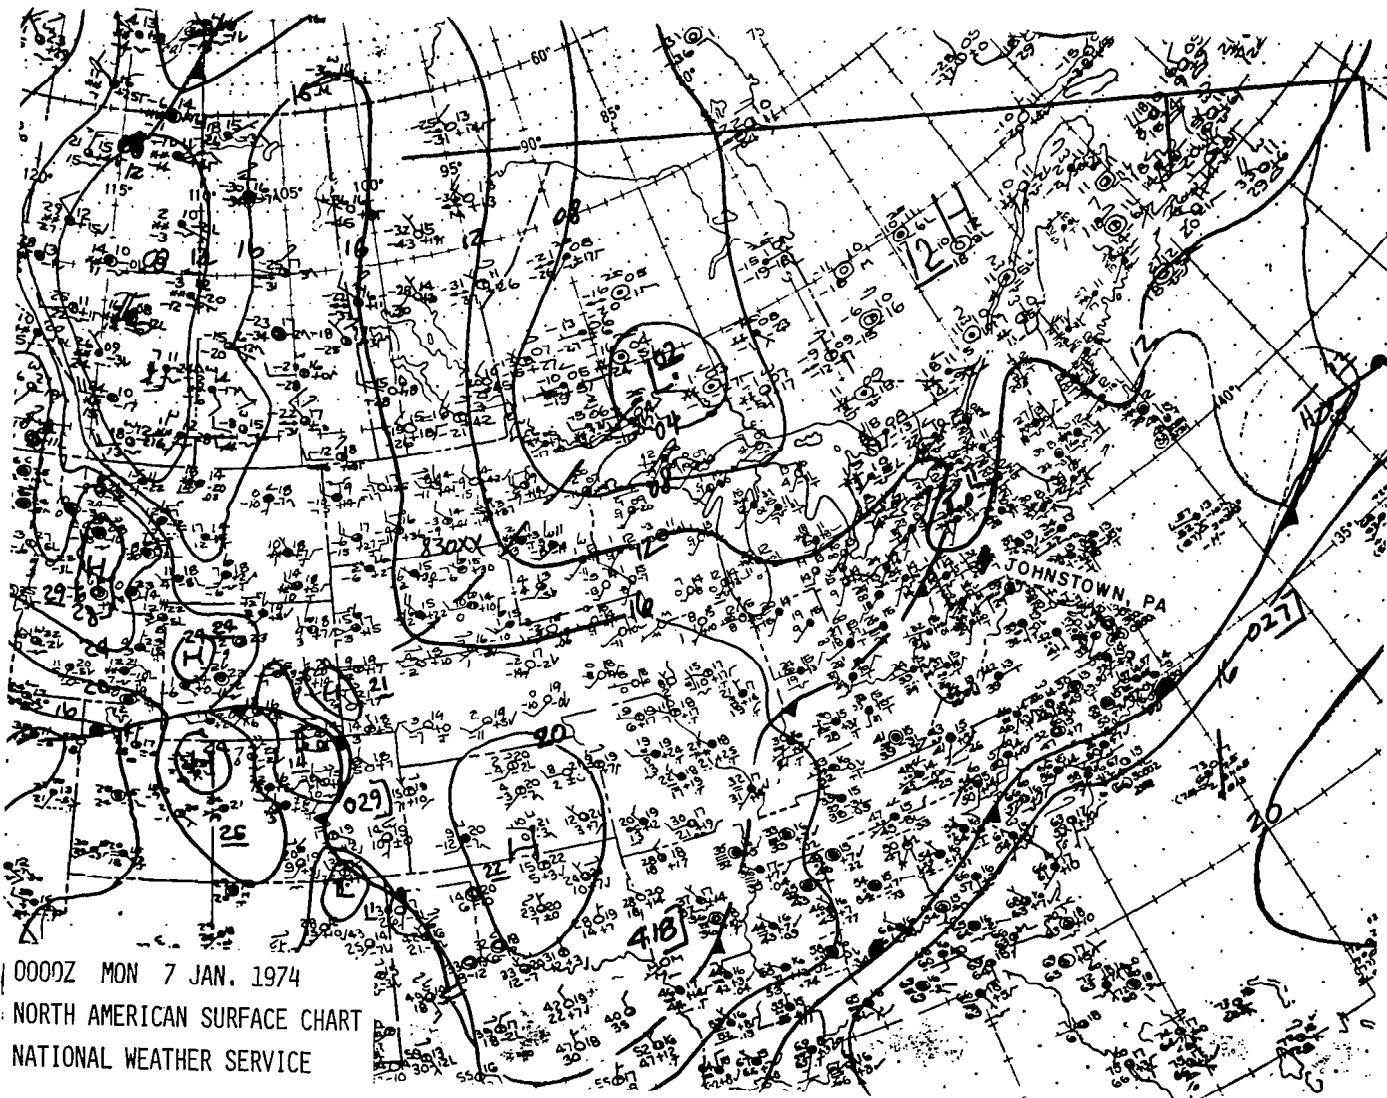
Figure 3.6.5. Late surface weather chart for Johnstown, Pa., January 6, 1974 accident.

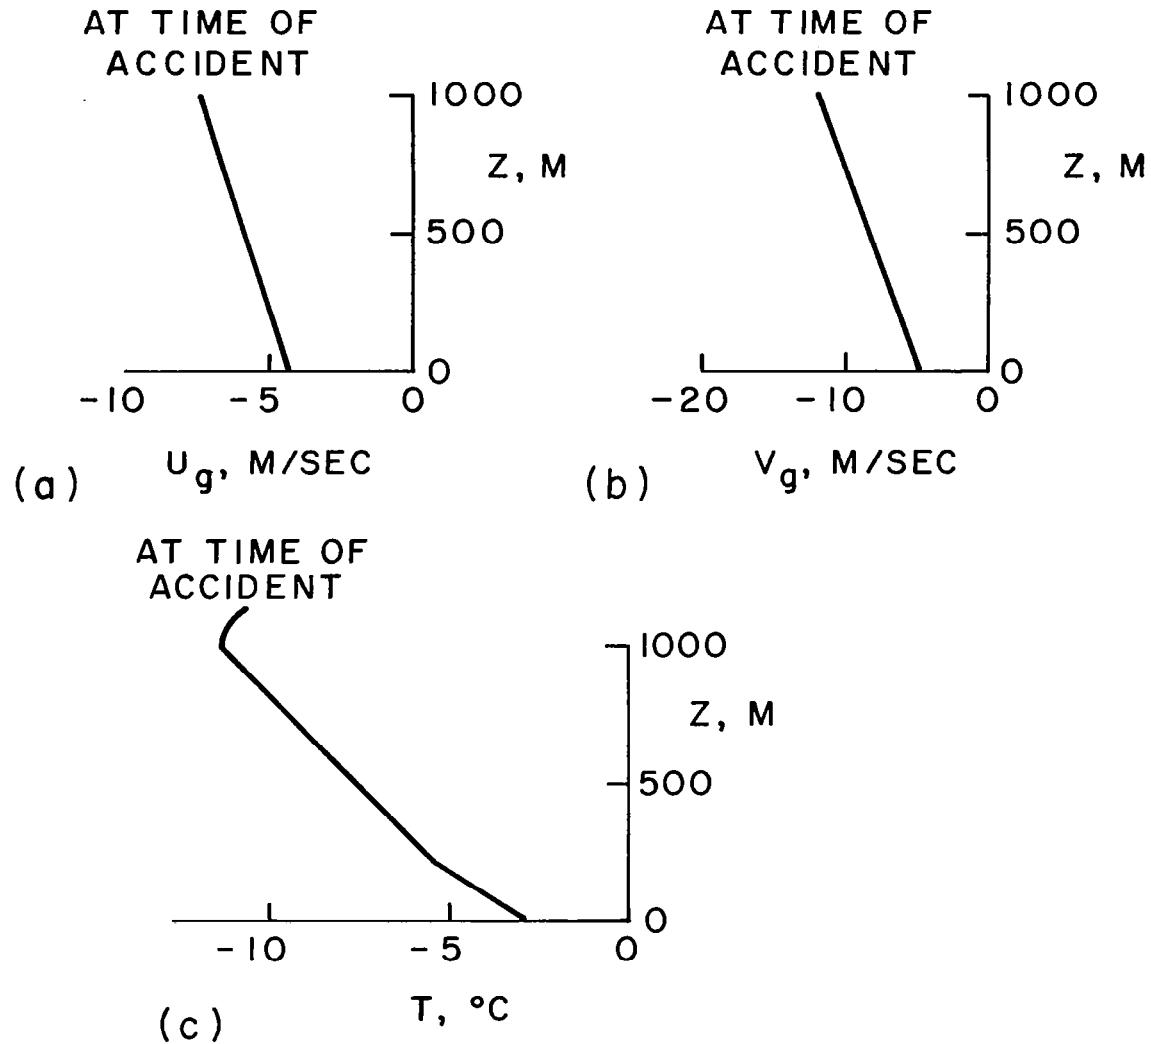
Figure 3.6.6. Altitude profiles for: a) mean geostrophic velocity component parallel to runway (+  $U_g$ , tailwind), b) mean wind velocity component perpendicular to runway (+  $V_g$ , crosswind from right), c) temperature before and after the Johnstown, Pa., January 6, 1974 accident.

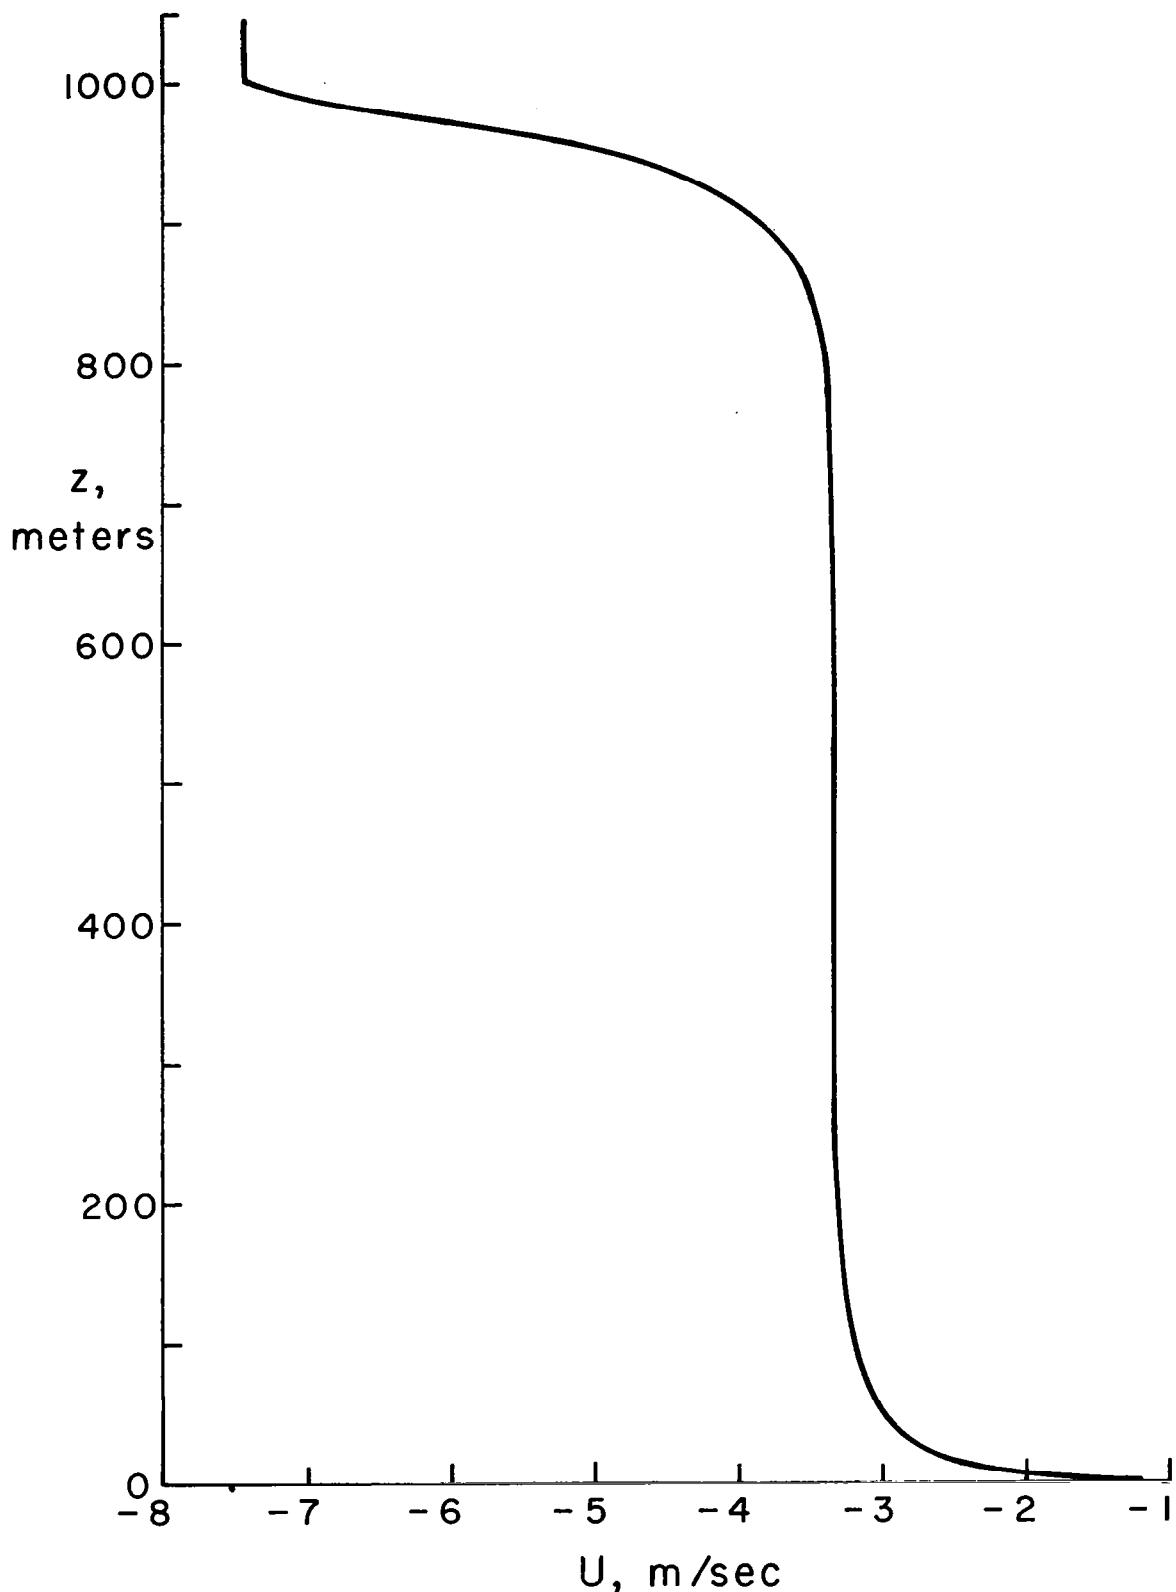
Figure 3.6.7. Altitude profile of mean wind velocity component parallel to runway (+ U, tailwind) for the Johnstown, Pa., January 6, 1974 accident.

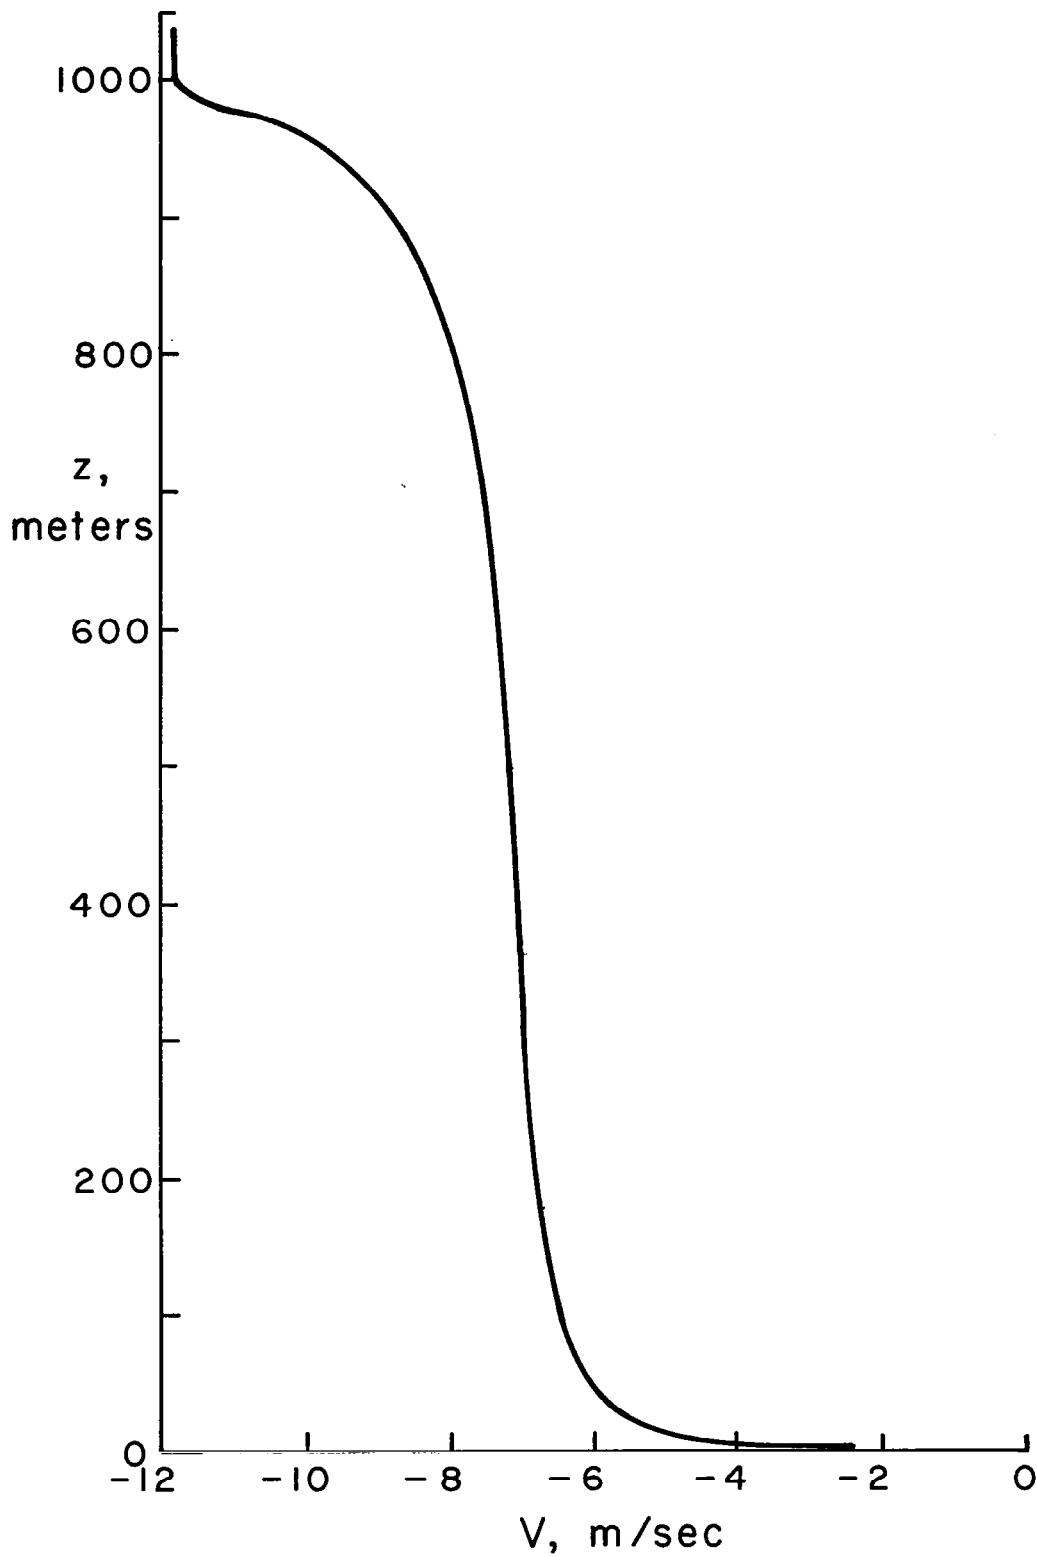
Figure 3.6.8. Altitude profile of mean wind velocity component perpendicular to runway (+ V, crosswind from right) for the Johnstown, Pa., January 6, 1974 accident.

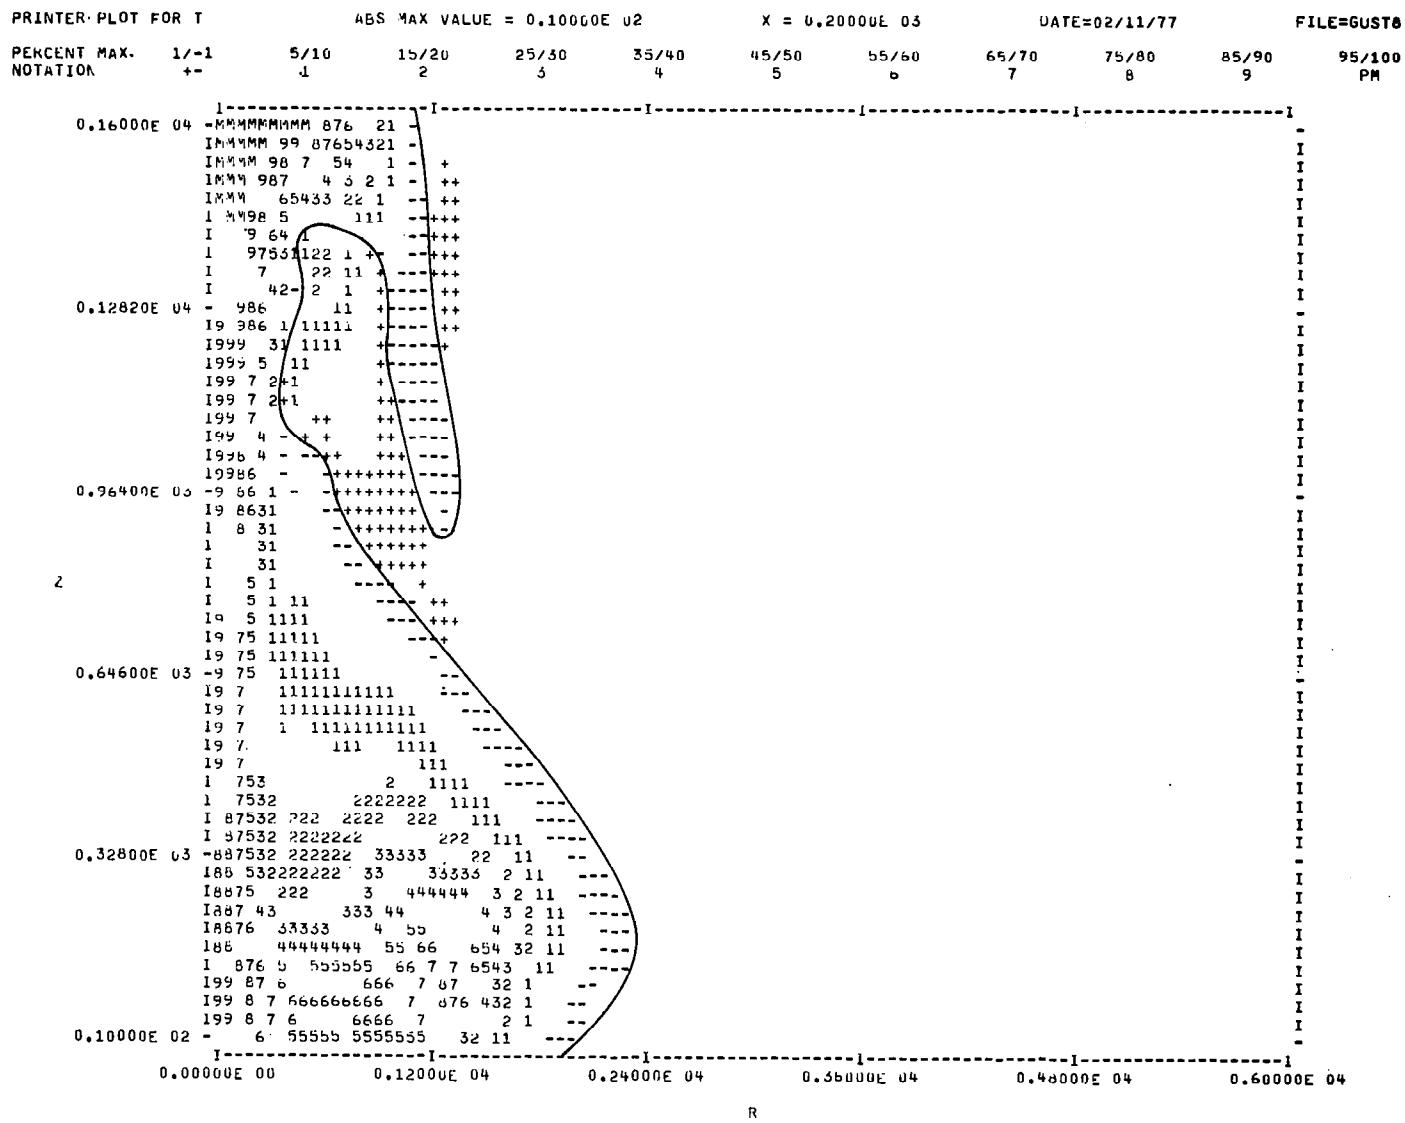
Figure 4.2.2. Normalized temperature contours as a function of  $z$  and  $R$  for an axisymmetric gust front with a 500 m radius downdraft at  $t = 200$  sec. [See figure 2.3.2 for explanation of notation.]

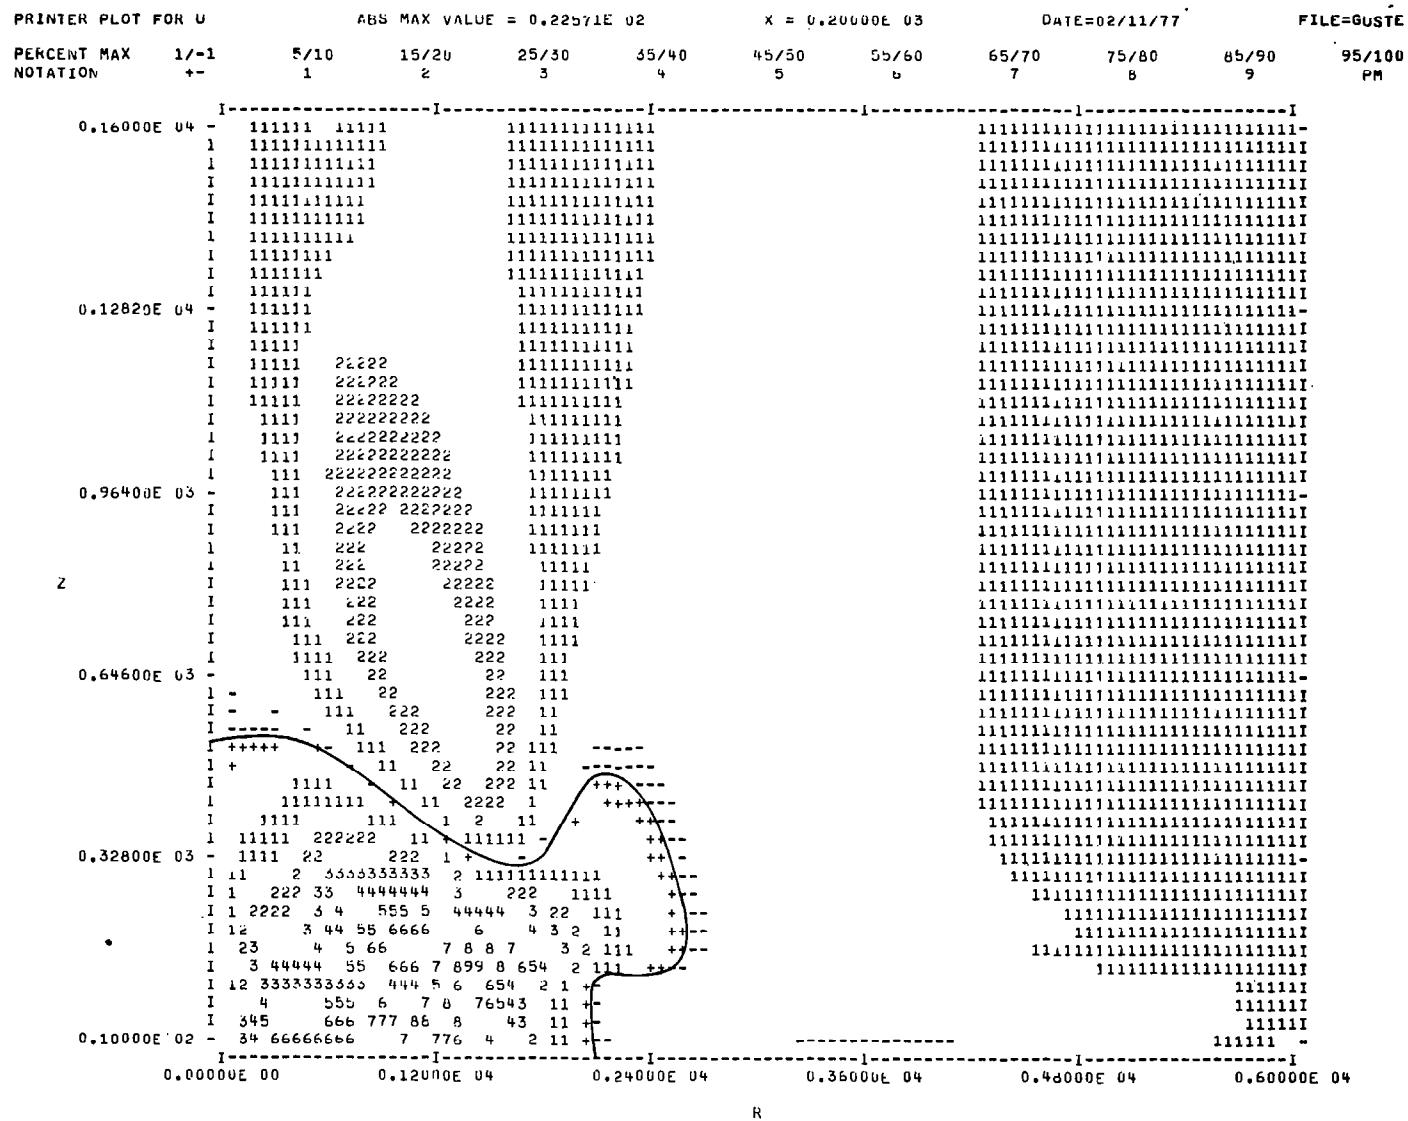
Figure 4.2.4. Normalized mean radial velocity contours as a function of  $z$  and  $R$  for an axis-symmetric gust front with a 500 m radius downdraft at  $t = 200$  sec. [See figure 2.3.2 for explanation of notation.]
